Report No: CEF-GXO-01

Lightico were asked to carry out an air quality audit to determine if CleanLight could provide a solution to allow GXO to once again accommodate all the systems staff in one office (pre-social distances changes) and return use of the rest room back to the drivers.

Summary:

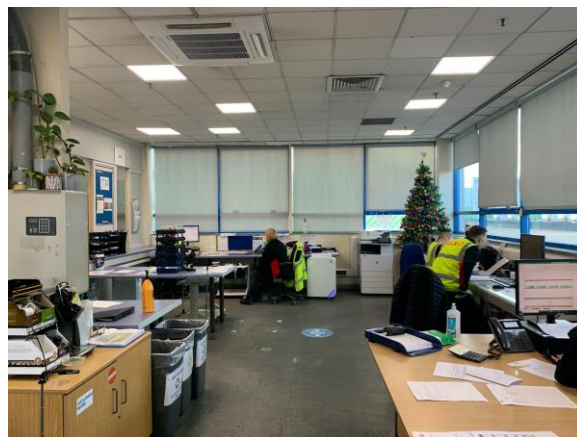
Main office ceiling layout and desk spacing

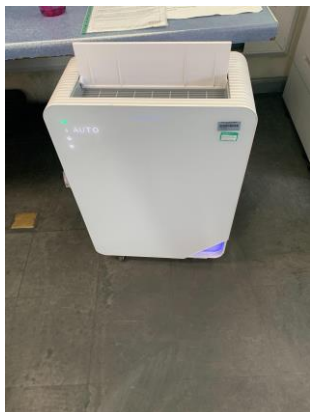
A portable air cleaning device was operating in the main office, given its location and size, it is estimated this unit would have an effective area of between 35 - 50m² as long as it was regularly maintained.

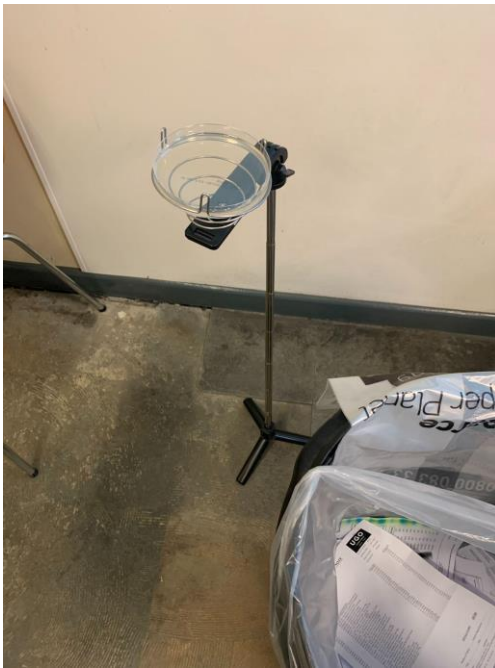
Agar plate collection - Putting On Area

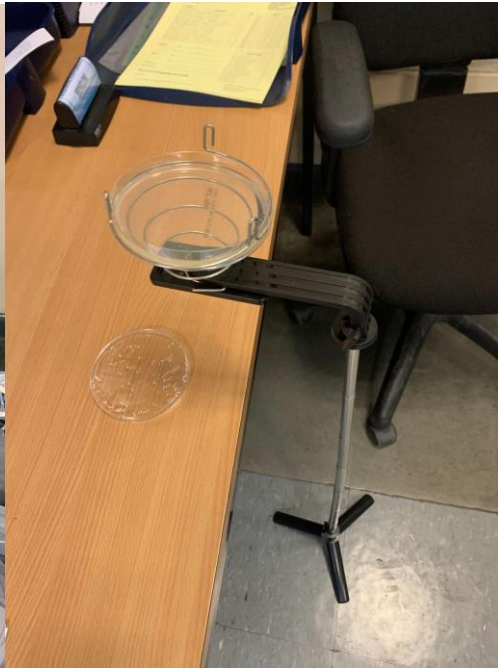
Agar plate collection - Main Office

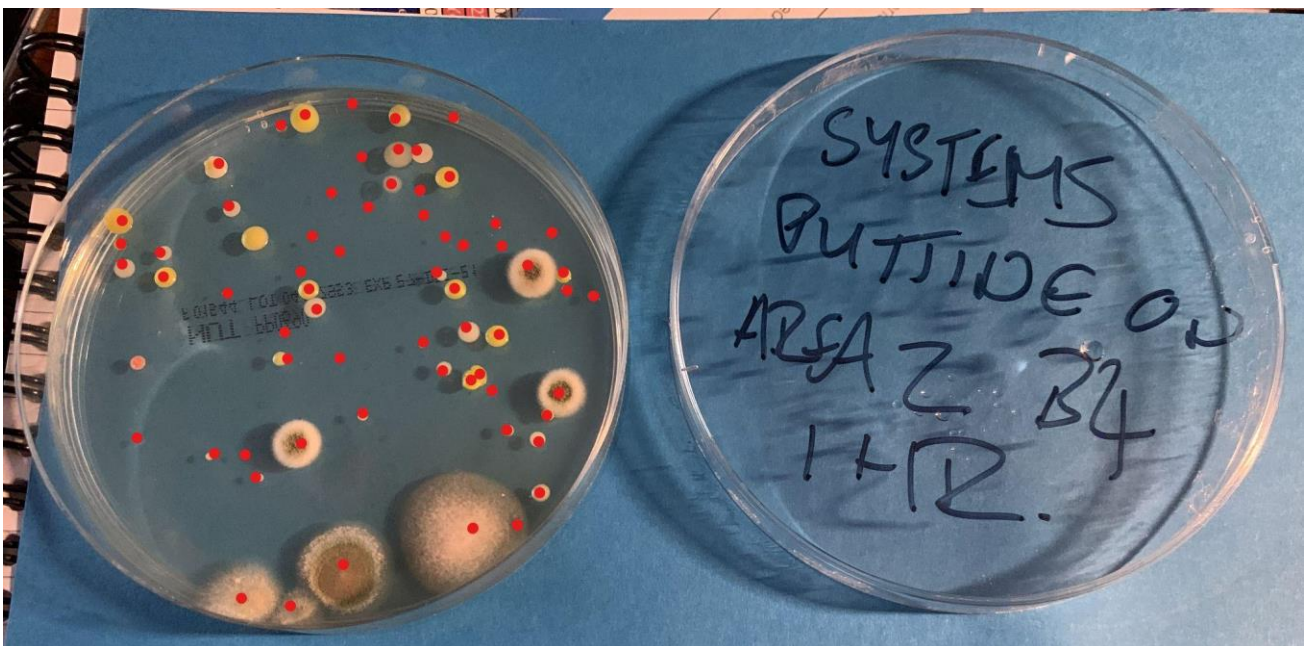
Plate location	Bacterial colony count (per plate) - TVC
Putting on Area - Location 1	64
Main Office - Location 1	112
Main Office - Location 2	94
Main Office - Coffee Machine	73
Goods in Entrance	53
